# Inspection Report

## Kyle's Home Inspections

1111 Sample Rd Drive Winchester, CA, 92596

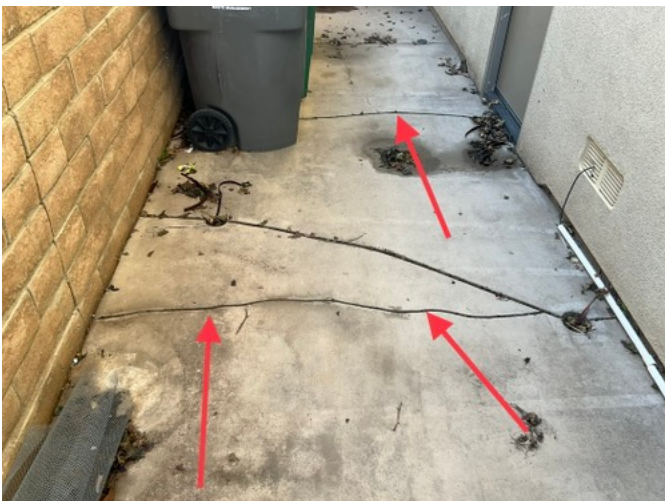
#### **1.3) Sidewalk Conditions**

The visible areas of the sidewalk appeared to be in serviceable condition at the time of the inspection. Common cracks of up to  $\frac{1}{4}$  inch were observed.

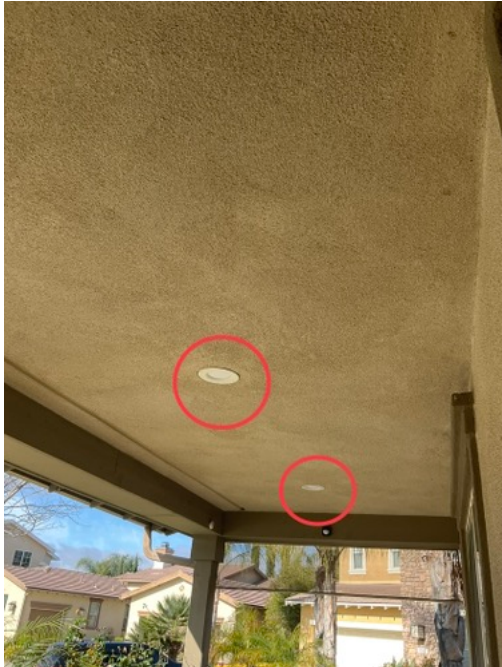
#### 2.1) Front Entrance Conditions

Front porch recessed lights not operable at time of inspection. It is suggested that a "Licensed Electrical Contractor" be contacted for further evaluation and repair.

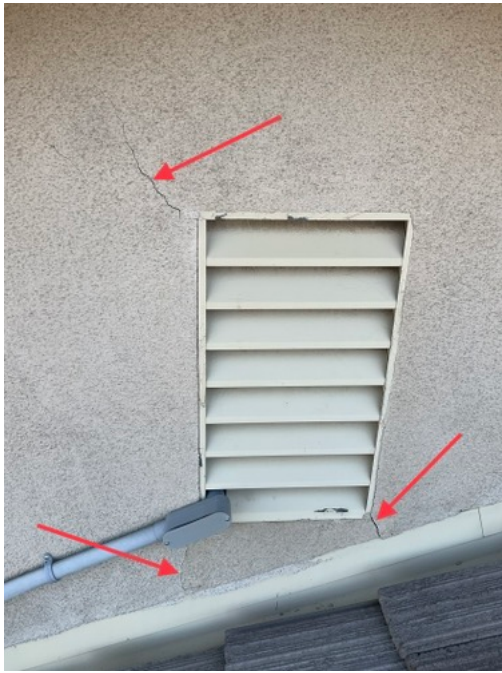
### **2.3) Exterior Wall Conditions**

The visible and accessible portions of the exterior wall coverings appeared to be in serviceable condition at the time of the inspection. Common cracks were found in the exterior walls.

Recommend sealing to reduce the possibility of water penetration.

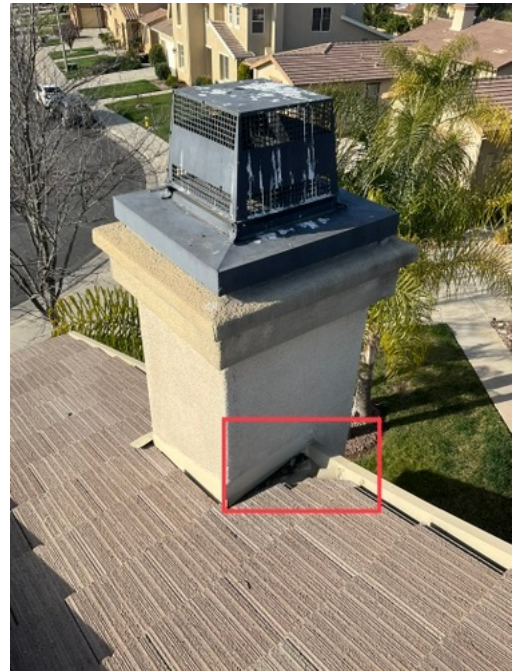
### 2.7) Chimney Conditions

The chimney and / or flue appear to be suffering from deferred maintenance. Recommend further evaluation and / or maintenance as needed by a mason or chimney specialist.

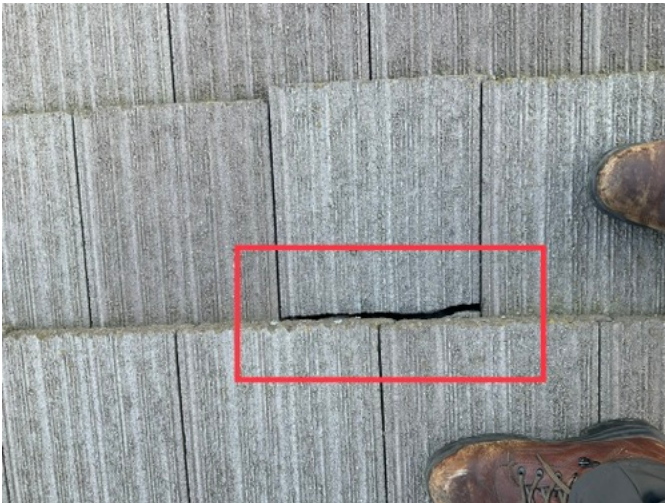
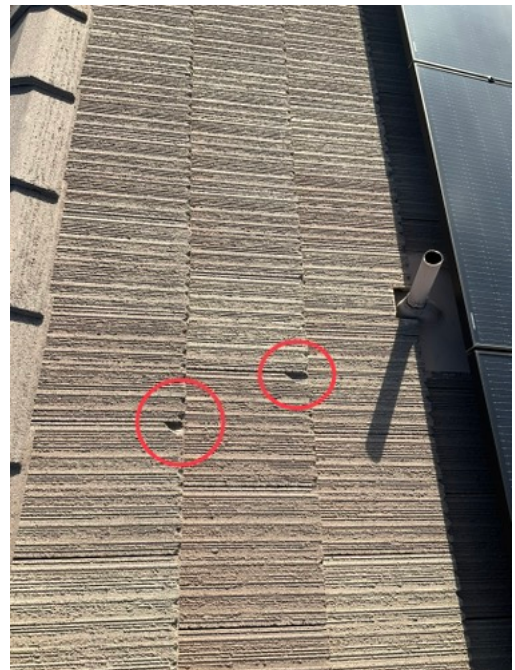
#### 3.1) Roof Covering Condition

Damaged or missing shingles were observed at . Recommend further evaluation and repair as needed by a qualified / licensed contractor. The inspector can not offer an opinion as to whether the roof leaks today unless it is moderately raining at the time of inspection. Client should obtain full disclosure / history information from the seller prior to close.

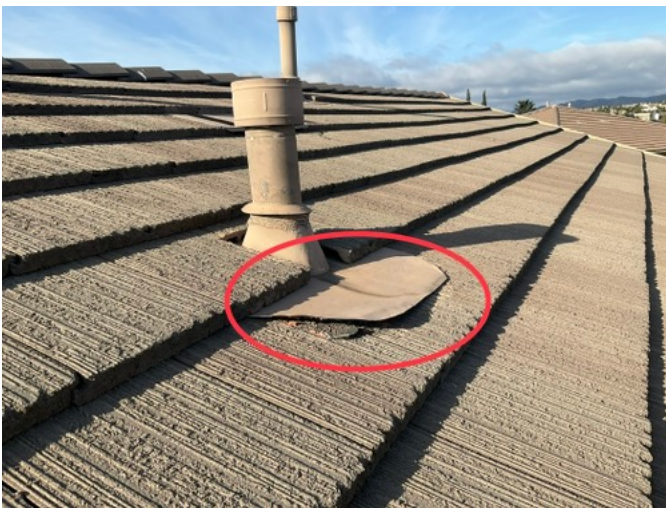
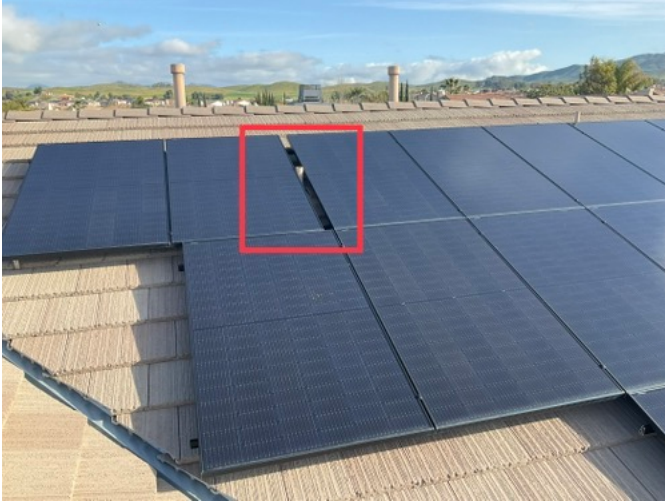
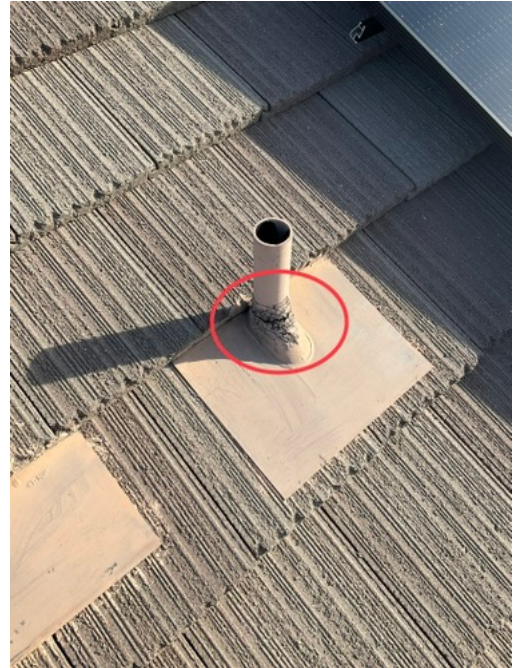
### 3.2) Flashing Conditions

Sealing is needed at all vent pipes, chimney, wall and valley seams, and any other through roof projections (including skylights if present) to reduce the possibility of water penetration.

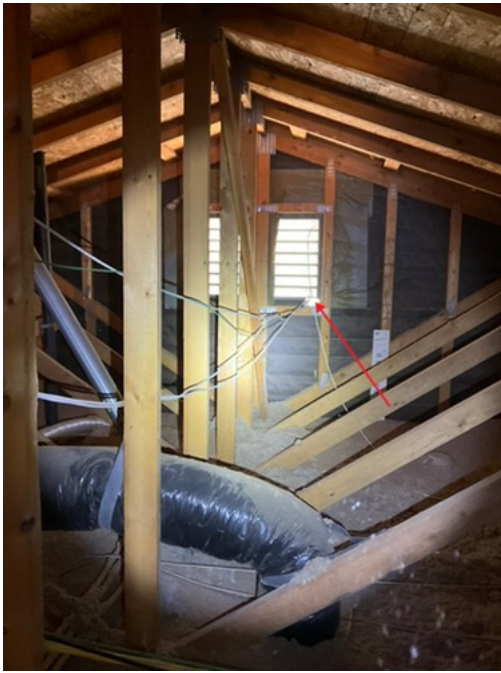
### 3.5) Attic Ventilation Conditions

The ventilation screens or gable vents were ripped or damaged and should be repaired or replaced. There was wiring ran out of the vent and the screen was cut to do so.

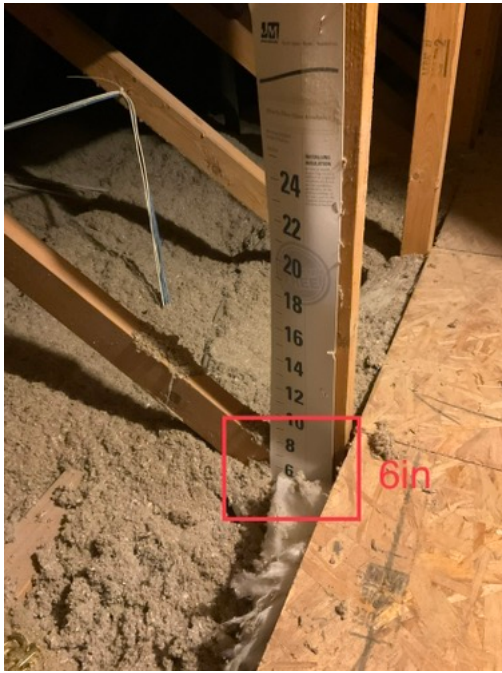
### **3.6) Attic Insulation Conditions**

The attic has minimal amount blown-in insulation. The approximate depth of the insulation is 6 inches. Additional insulation should be considered.

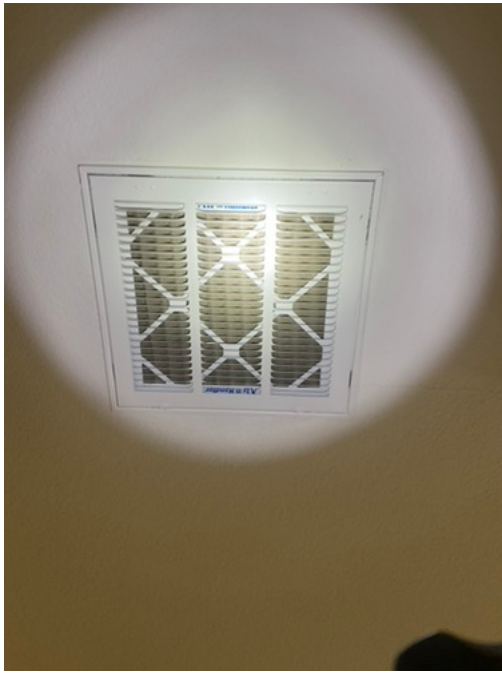
#### 4.1) Unit Conditions

The heating system was operational at time of inspection. This is not an indication of future operation or condition. The air filter was dirty. Suggest replacing as soon as possible. To increase the efficiency of your heating system, we recommend changing your systems fir filter(s) regularly ( every 2-3 months ).

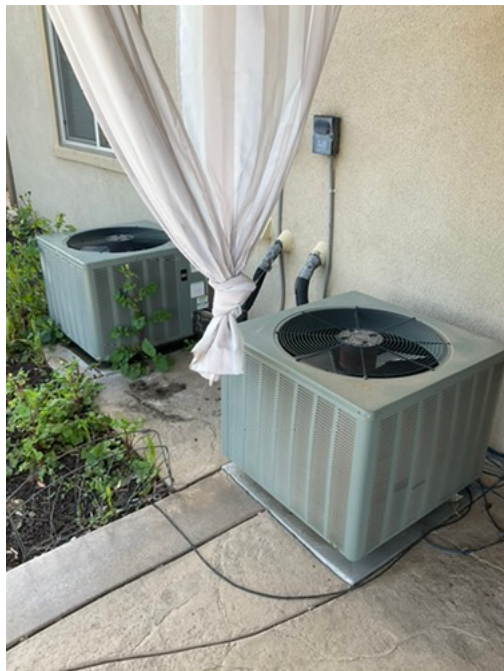
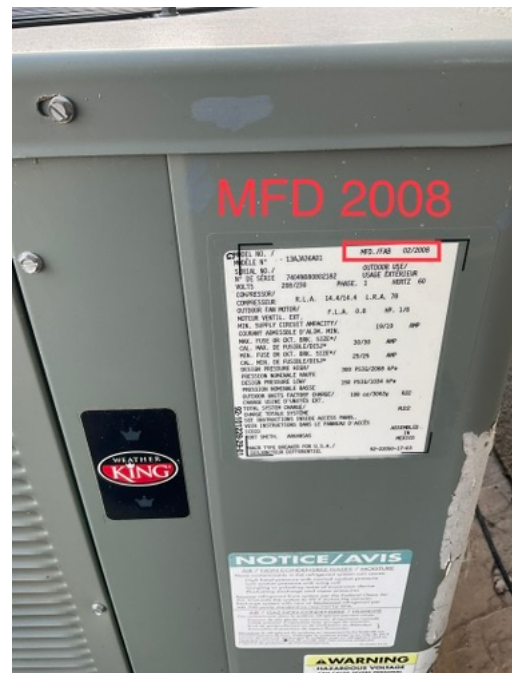
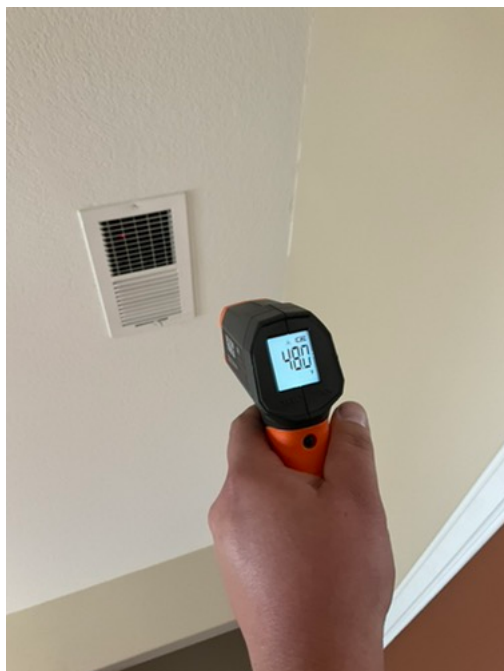
### 4.5) AC Unit Conditions

It was observed that the condenser coil was dirty and in need of cleaning and service.  
Manufactured 2008. Temps read at 48

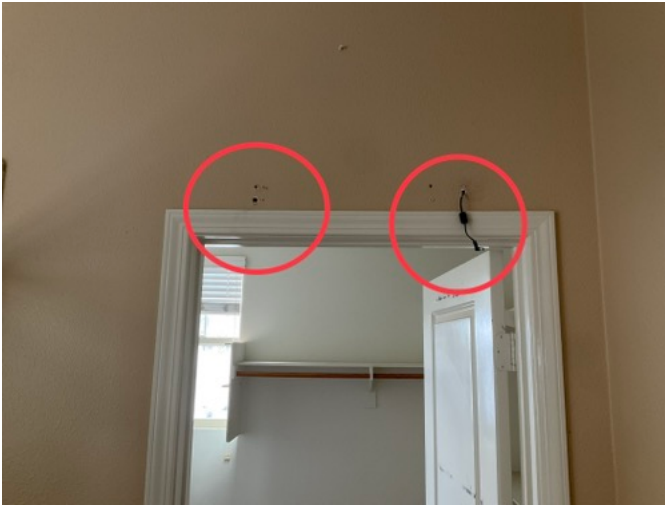
#### 7.1) Wall Conditions

The interior walls had small holes throughout home. Recommend maintenance as needed.

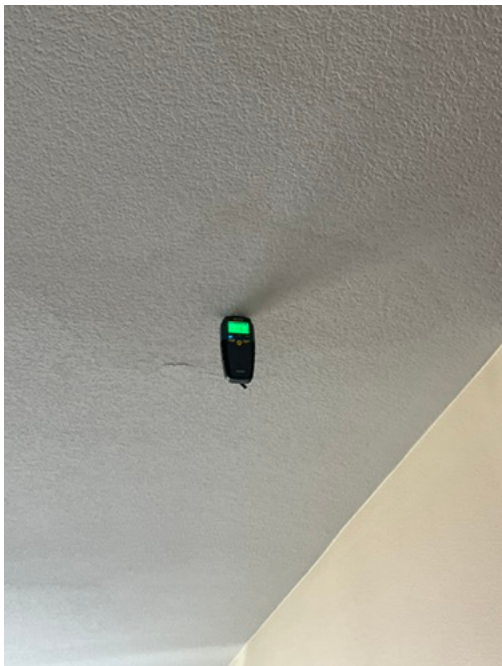
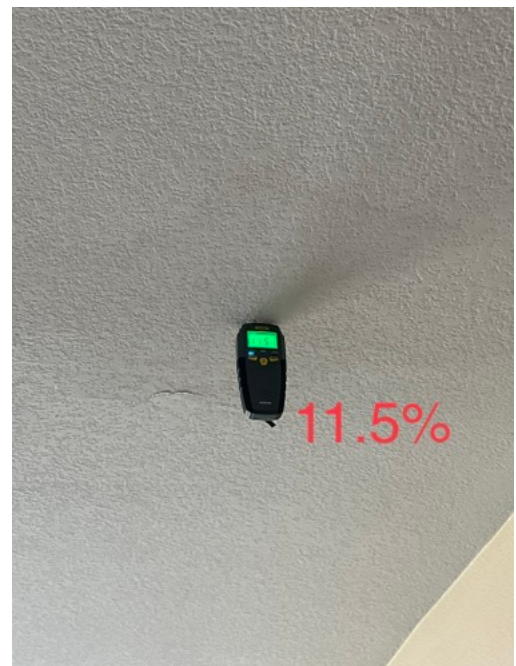
#### 7.2) Ceiling Conditions

Moisture damage was observed at main living area. Hidden damage may exist in areas not readily visible or accessible. Moisture read at 11.5%. It is suggested that a "Licensed Roofing Contractor" be contacted for further evaluation and repair. Thermal gun picked up moisture in the area of the leak on the adjacent wall facing it.

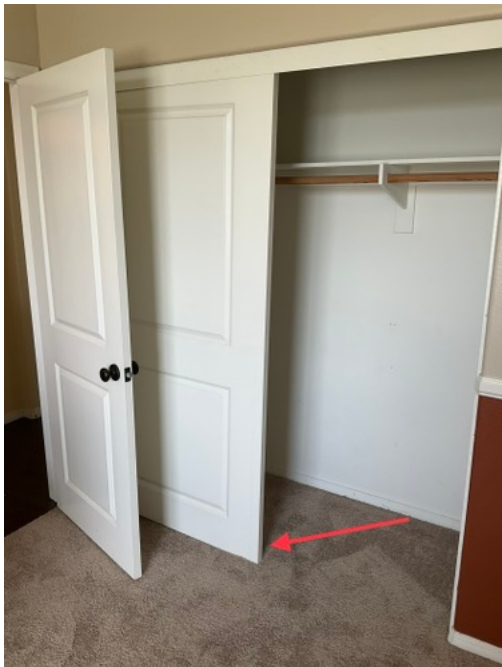
#### 7.6) Interior Door Conditions

The closet doors were loose or difficult to operate. Repairs and / or adjustments are recommended.

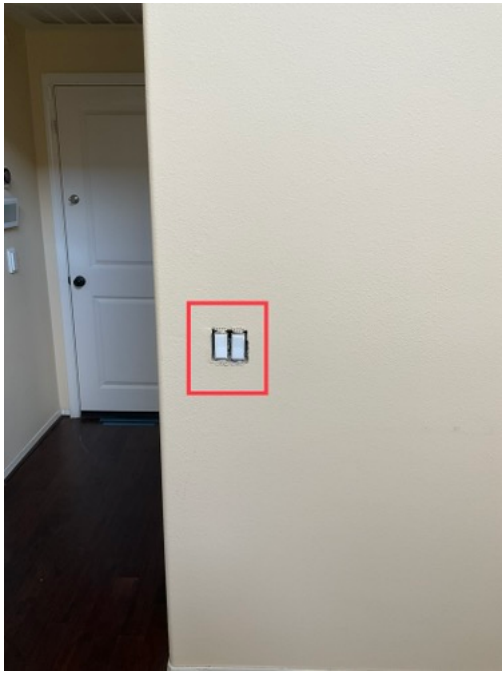
##### 7.7) Electrical Conditions

Missing receptacle or switch covers were observed at living room. Recommend covers be installed for safety.

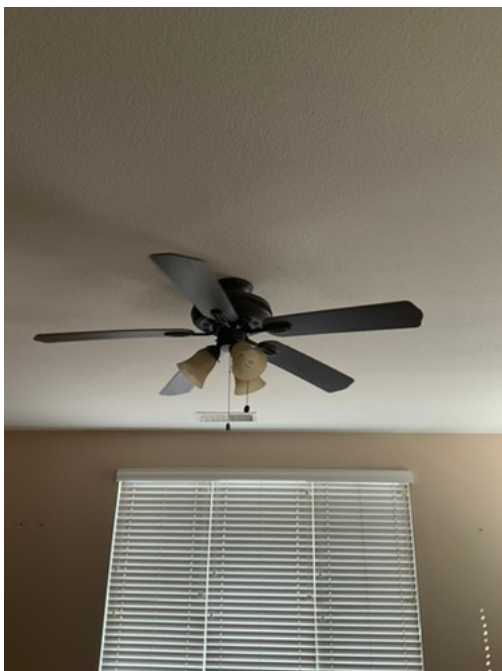
#### 7.9) Ceiling Fan Conditions

The ceiling fan(s) was not operational at 2nd floor master bedroom. Recommend further evaluation and repair as needed by a qualified / licensed contractor.

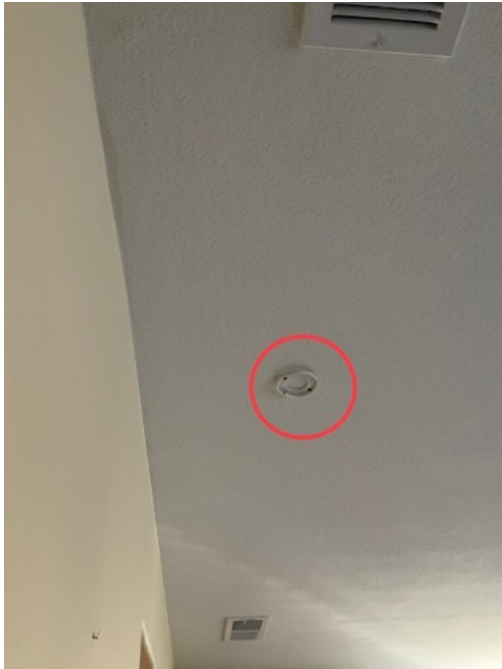
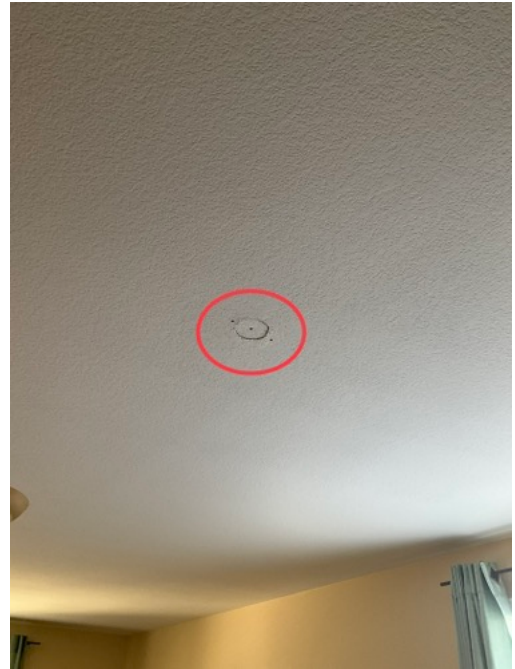
#### 7.10) Smoke Detector Conditions

No smoke detectors were found at the time of the inspection. Recommend smoke detectors on each level and near or in each bedroom. Client should contact the local Fire o Marshall's office for proper locations.

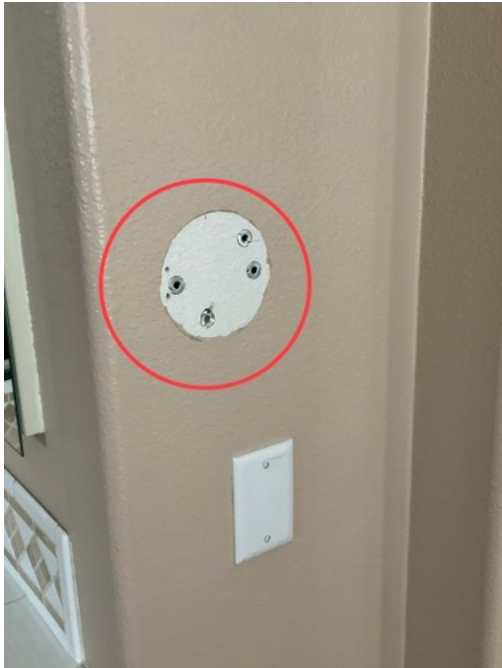
#### 9.1) Wall Conditions

The walls had small holes. Recommend maintenance as needed.

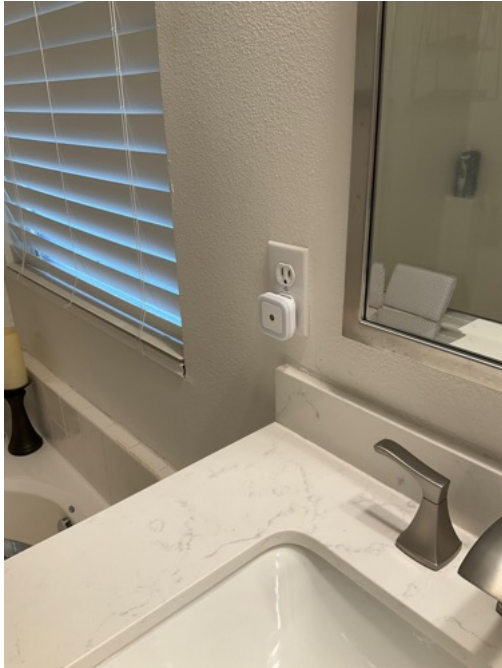
### 9.7) Electrical Conditions

GFIC (Ground Fault Interrupter Circuit) receptacle circuit (a safety device for outlets near water) recommended It is suggested that a "Licensed Electrical Contractor" be contacted for further evaluation and repair.

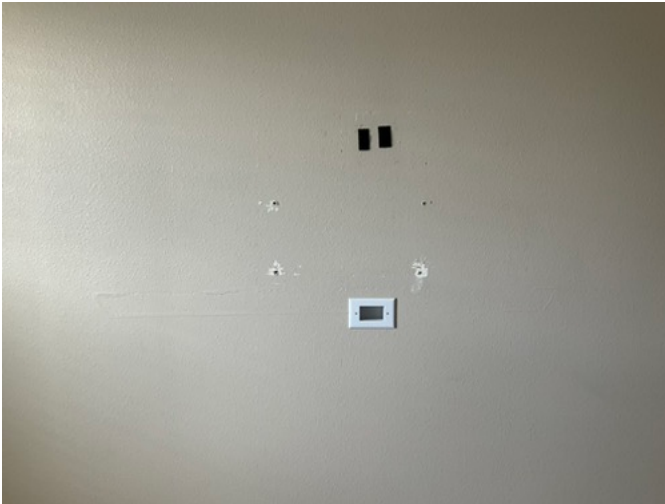
**10 Bedroom(s)****Walls - Ceilings - Floors****10.1) Wall Conditions**

The walls had small holes. Recommend maintenance as needed.

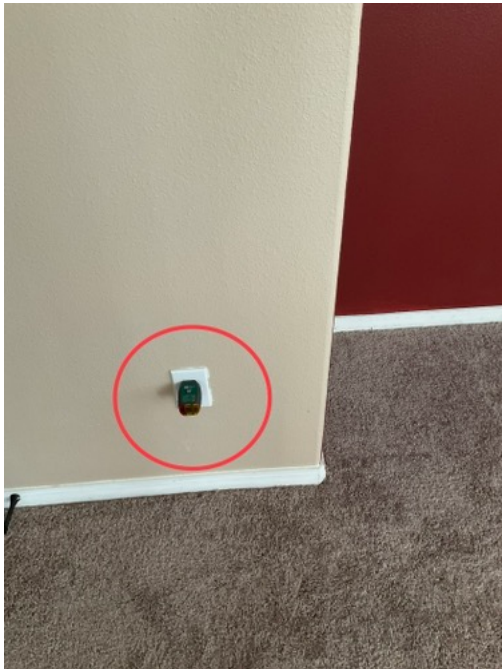
**Electrical Conditions****10.7) Electrical Conditions**

Multiple bedroom outlets had no power to them. It is suggested that a "Licensed Electrical Contractor" be contacted for further evaluation and repair.

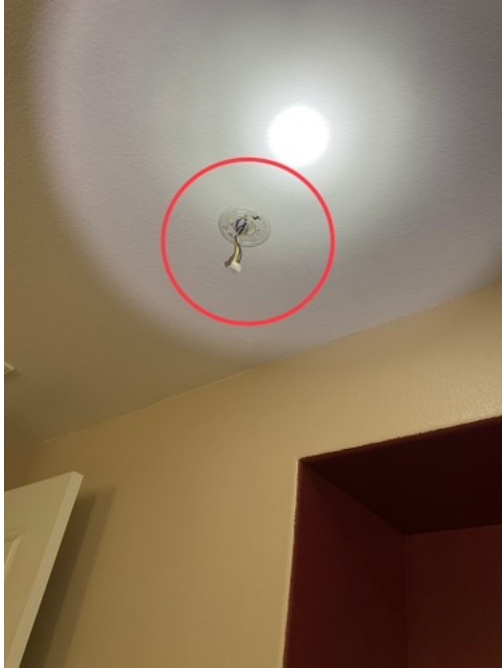
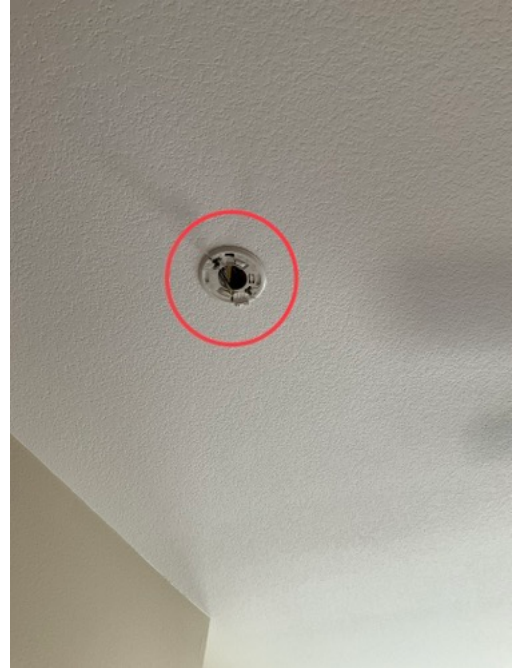
**10.10) Smoke Detectors Conditions**

No smoke detectors were found at the time of the inspection. Recommend smoke detectors on each level and near or in each bedroom. Client should contact the local Fire o Marshall's office for proper locations.

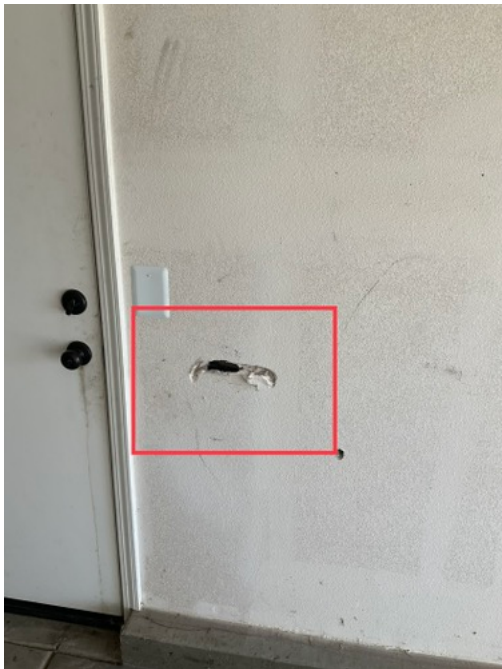
#### 11.3) Wall Conditions

The interior walls had small holes. Recommend repairs as needed.
